# Q Class 541 Overhaul Update

By Chris Hunford, Maunsell Locomotive Society project manager

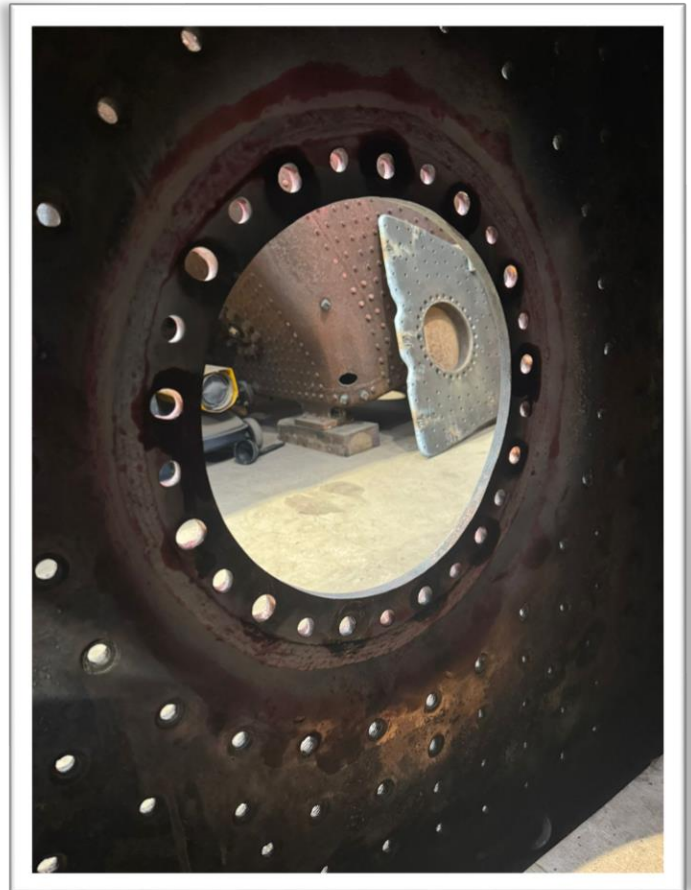
***Previous page:*** Repaired copper firebox door ring, with new section of steel backhead in background

In the run up to Christmas, the focus of work on 541's boiler has been the replacement of the copper door ring on the inner firebox. This area of the boiler had become life expired and in particular the areas around the rivet holes, where the rivets pass through this platework, the firehole door ring and the backhead. The decision was made to insert a new piece of platework and weld this in position, which is now complete and successfully passed its Non-Destructive Testing exam. See accompanying photos.

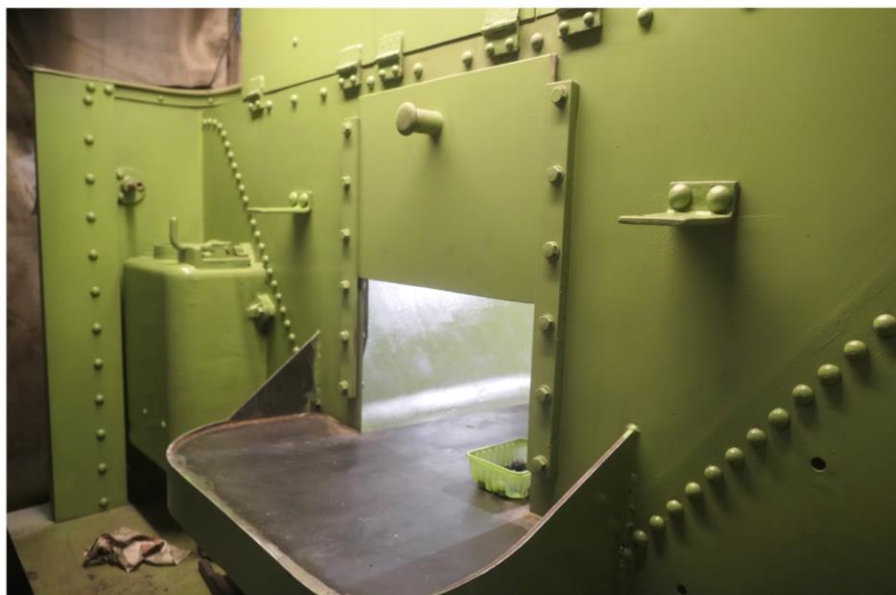
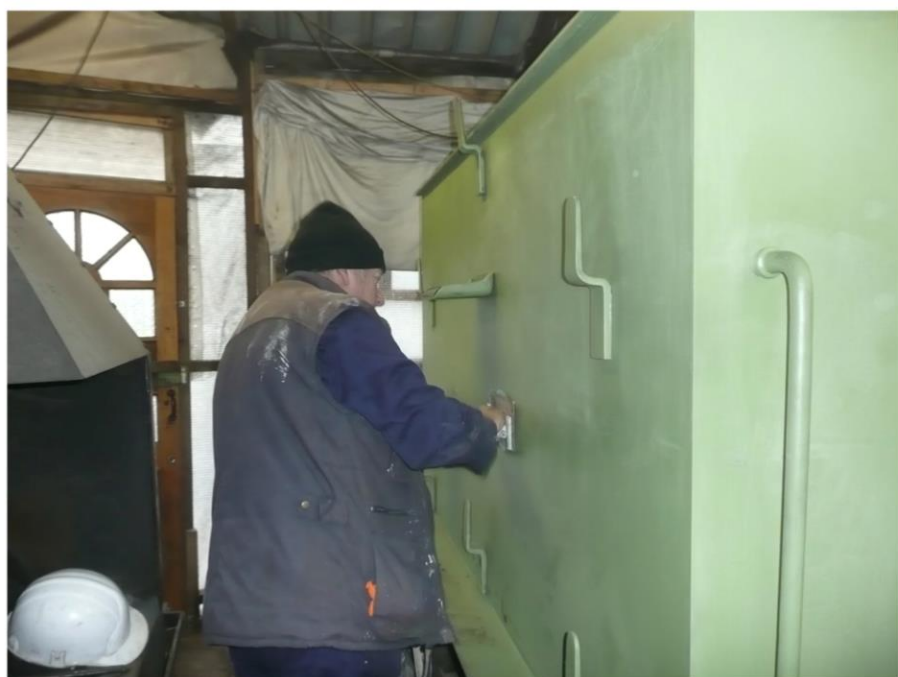
***This page:*** The newly-painted front and rear of the tender tank.  
*Photos courtesy 4253 group*

At Rolvenden, the 4253 Group has pressed on with concluding work on the tender body and since the last report the rear section of the tank has been welded into place. In recent weeks the group has been painting the exterior of the tender tank.
