# Q Class 541 Overhaul Progress

By Steve Pilcher and Chris Hunford, Maunsell Locomotive Society

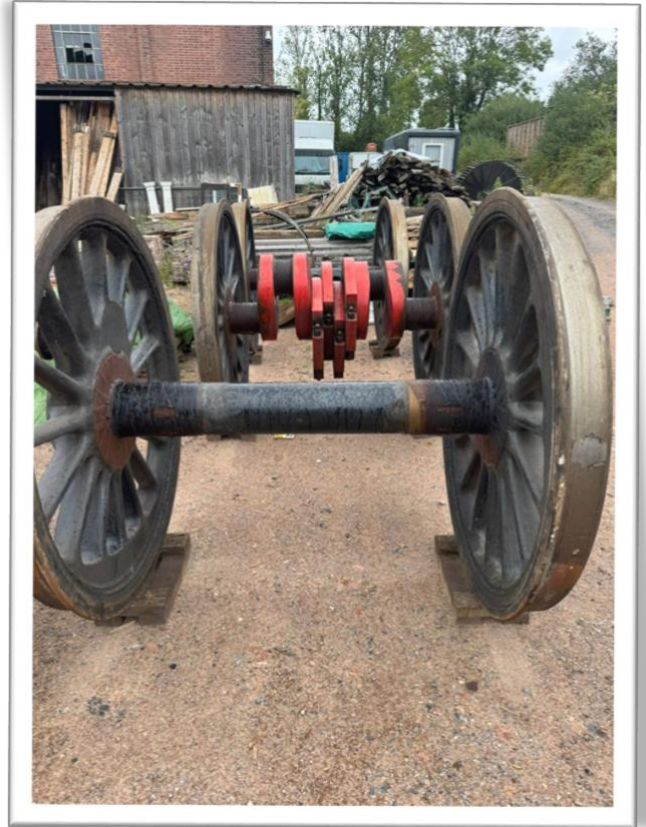
**Top:** Q class wheelsets after turning of journals and thrust faces.  
Photo: Leaky Finders

Meanwhile down at Leaky Finders works in Devon, the driving wheels have returned from the South Devon Railway having had their journals and thrust faces machined. Work can now start on setting everything up for machining of the new crowns. The new lefthand side frame insert is drilled and ready for fitting. Before this can be completed, the horn blocks require some cast iron welding repairs which will be completed at a specialist supplier. Once returned these and the frame insert can be fitted.

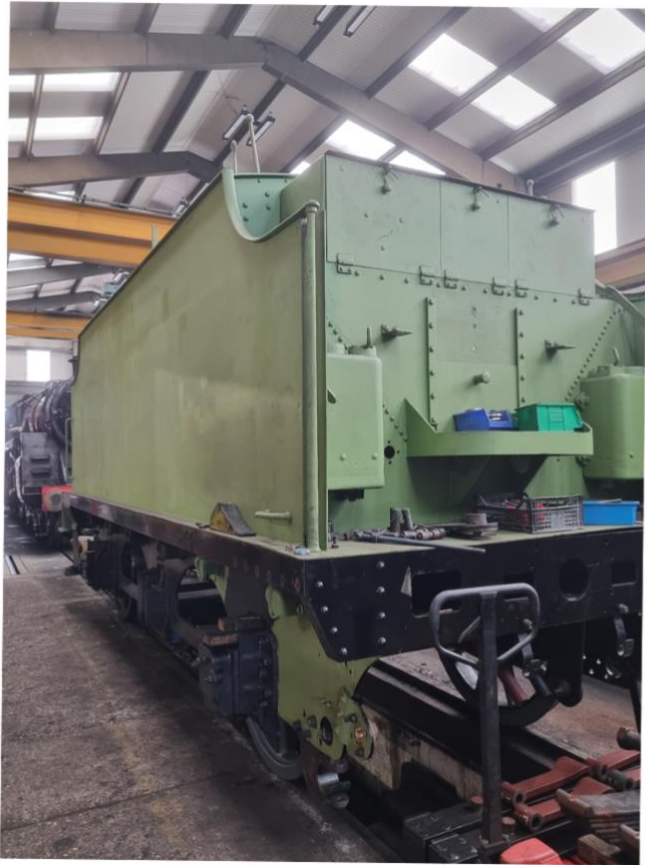
**Left:** Another view of the new tender tank and chassis temporarily re-wheeled.
