## Q Class 541 Overhaul Update

By Chris Hunford and Steve Pilcher, Maunsell Locomotive Society

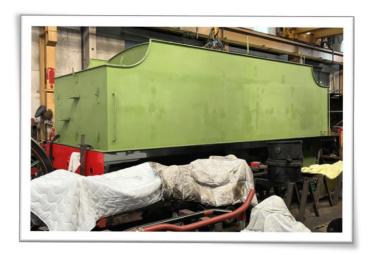
**Top:** New tender tank placed on the tender chassis for drilling and fitting of new holding down bolts. Photo Melvyn Frohnsdorff

April has seen a significant step forward in the overhaul of Q class 541 with the delivery of the new tender tank to Sheffield Park on the 9 April. After being temporarily placed on the ground within the Loco Works, the new tank is now sitting on the chassis to enable the holes for the holding down bolts to be drilled. Once complete and after a bit of 'fettling', the new tank will be permanently bolted to the chassis. Our thanks and appreciation must go to our friends at the 4253 Locomotive Group who have done a first-class job fabricating the new tank.

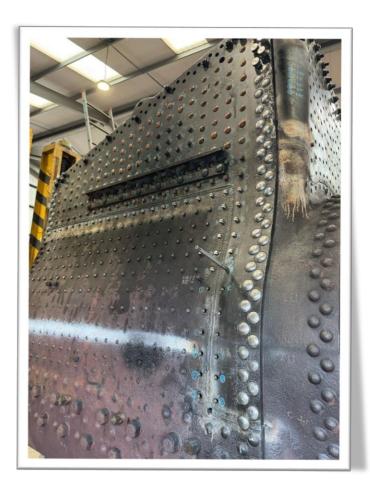
**Bottom:** Completed patch screws on the new outer wrapper. Photo courtesy Leaky Finders

Meanwhile in the south west of England at Leaky Finders, work is continuing on the loco's boiler and chassis. The machining of over 300 new monel stays for the boiler is almost complete while work to fit the new patch screws to the new outer wrapper boiler plate is finished.

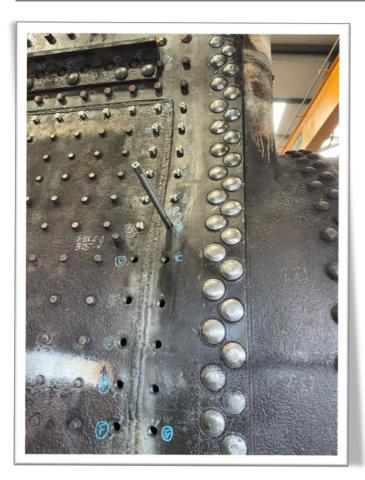
**Left:** Completed copper and monel stays plus tapping the remaining holes on the new outer wrapper. Photo courtesy of Leaky Finders.

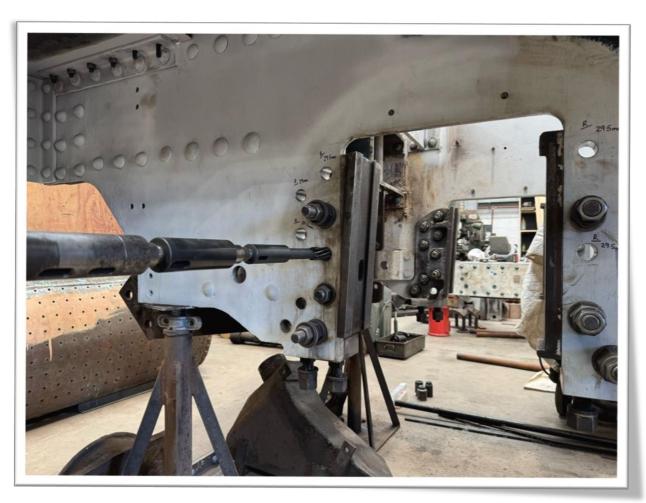
**Below:** Reaming of the main frame holes ready for attaching the horns with new fitted bolts. Photo courtesy of Leaky Finders.

Alongside the boiler work, three areas of the chassis have progressed. The removal, reaming, countersinking, supply and fitting of new fitted bolts for the lefthand and righthand side cylinder blocks has been completed, while on the main loco frames, the reattachment of the leading and driving horns with new fitted bolts and nuts is complete.
