### **Winter track re-laying: Joining up the previously re-laid sections. Week 2 – January 2022**

*This report covers the second week of the re-laying of 311 yards of track at Milepost 9/1 between Lindfield Wood and Waterworks.*

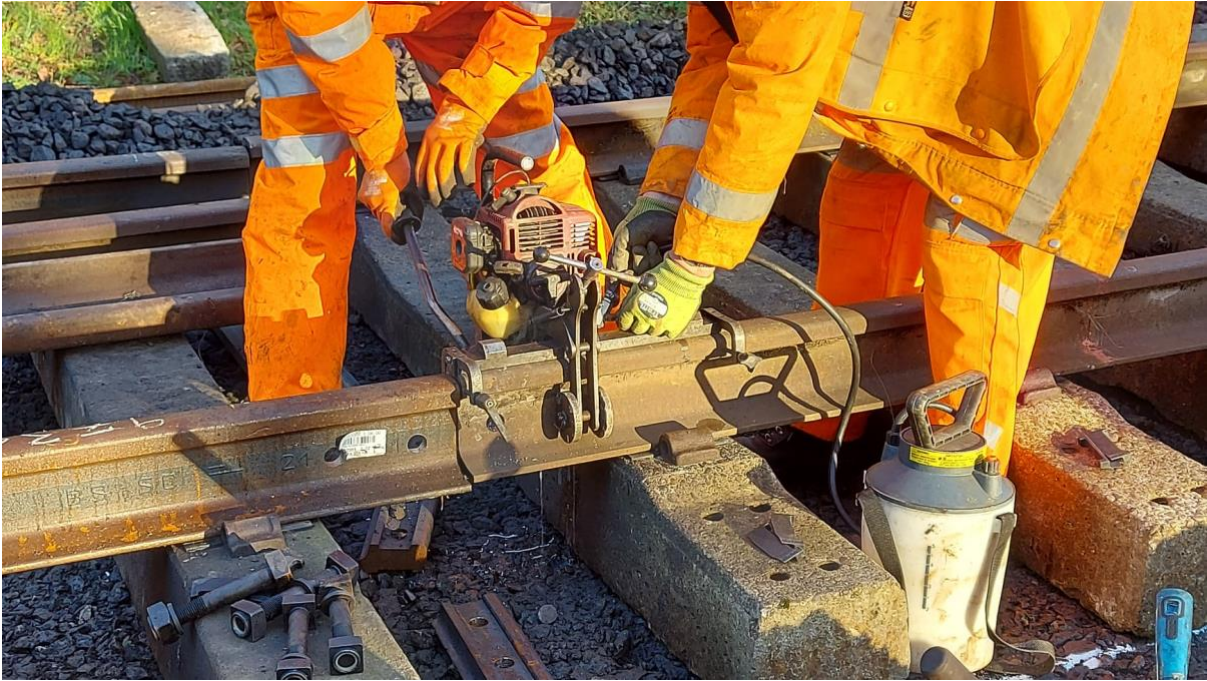
Closure rails fitted, completing 15½ panels of the winter track relay. Closures cut to length and drilled.

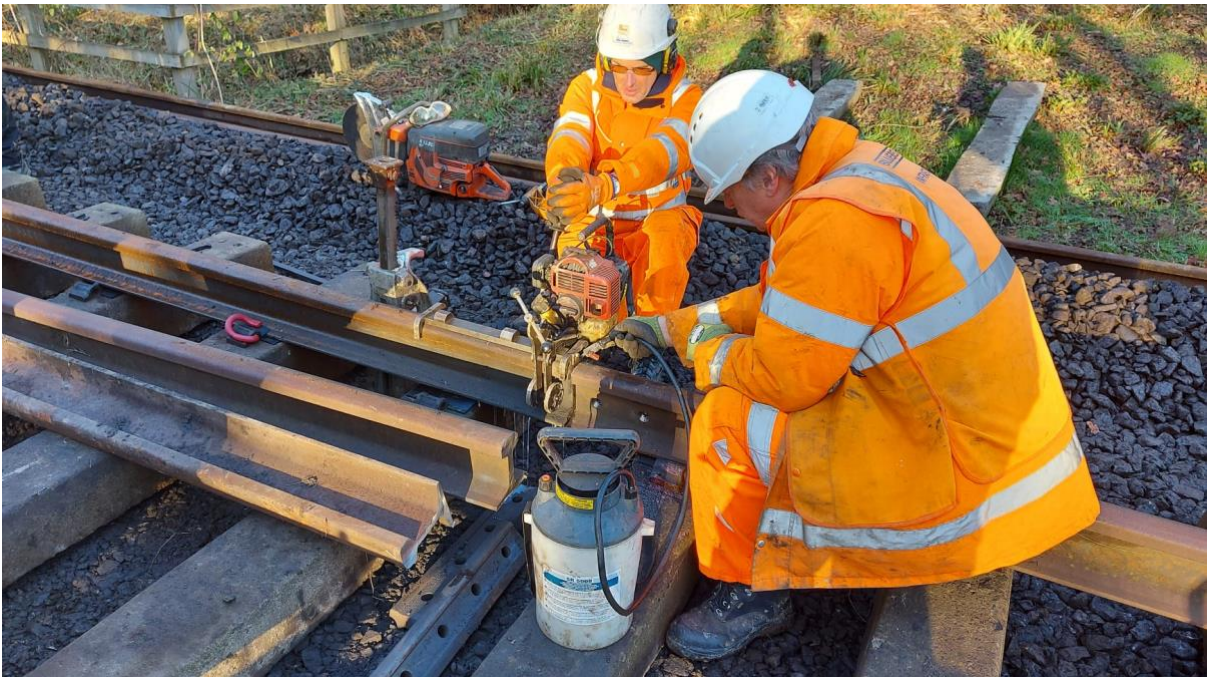
Drilling the fishplate holes on the closure rail – using cutting fluid (which is mainly water with a little bit of cutting oil mixed in).

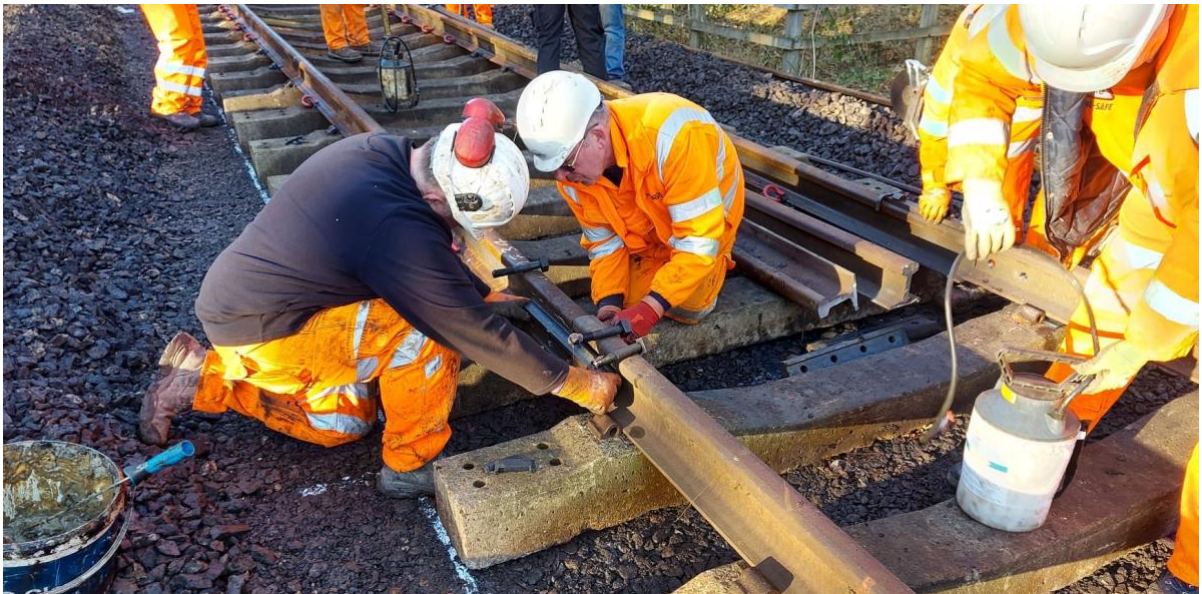
Plenty of grease on the plate bearing surfaces and on the bolt threads. Bolts done up with a Milwaukee impact driver but then finally tightened up with a hand spanner.

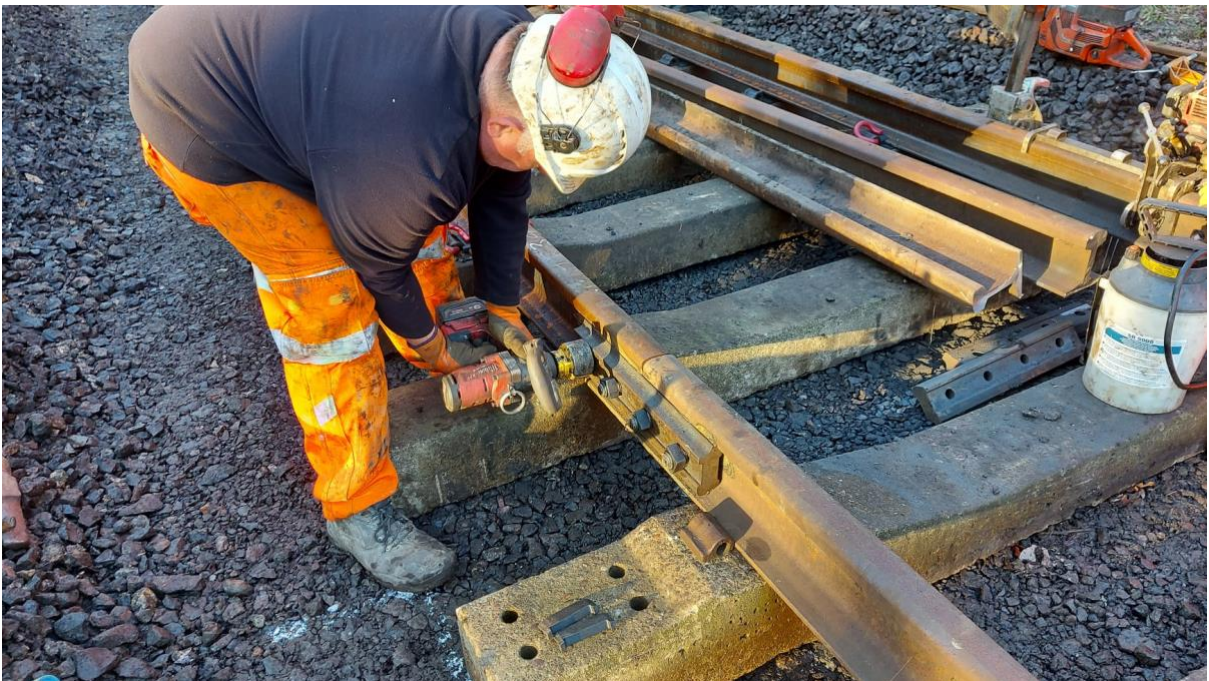
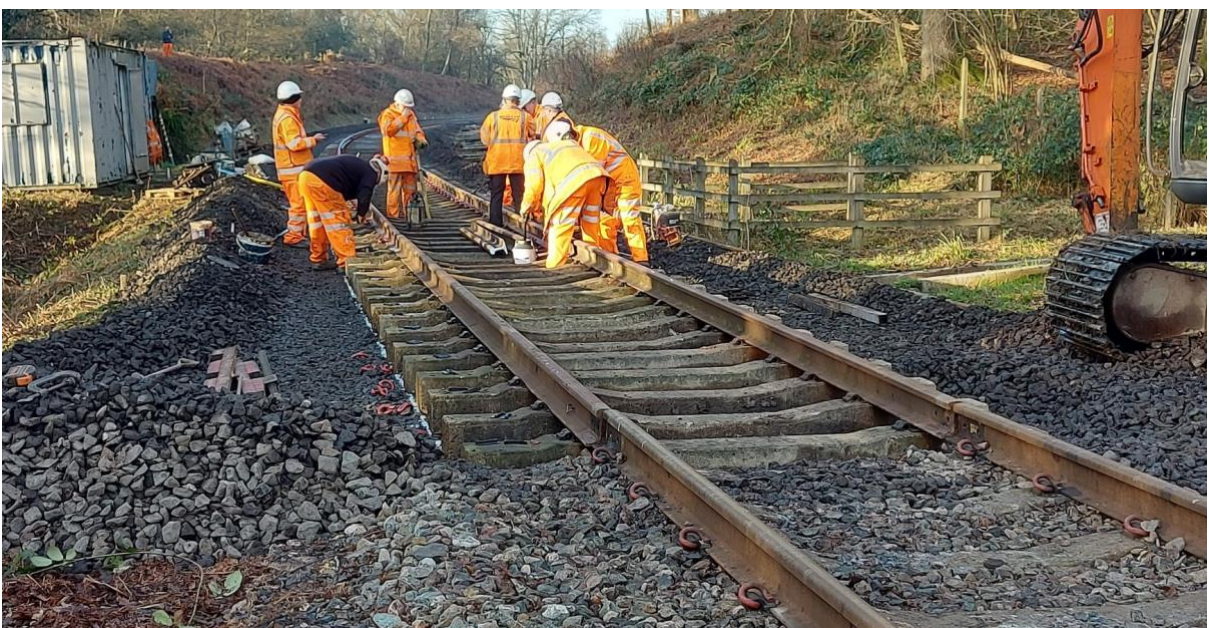
The stop board just past the laser dozer is on last winter's relay.

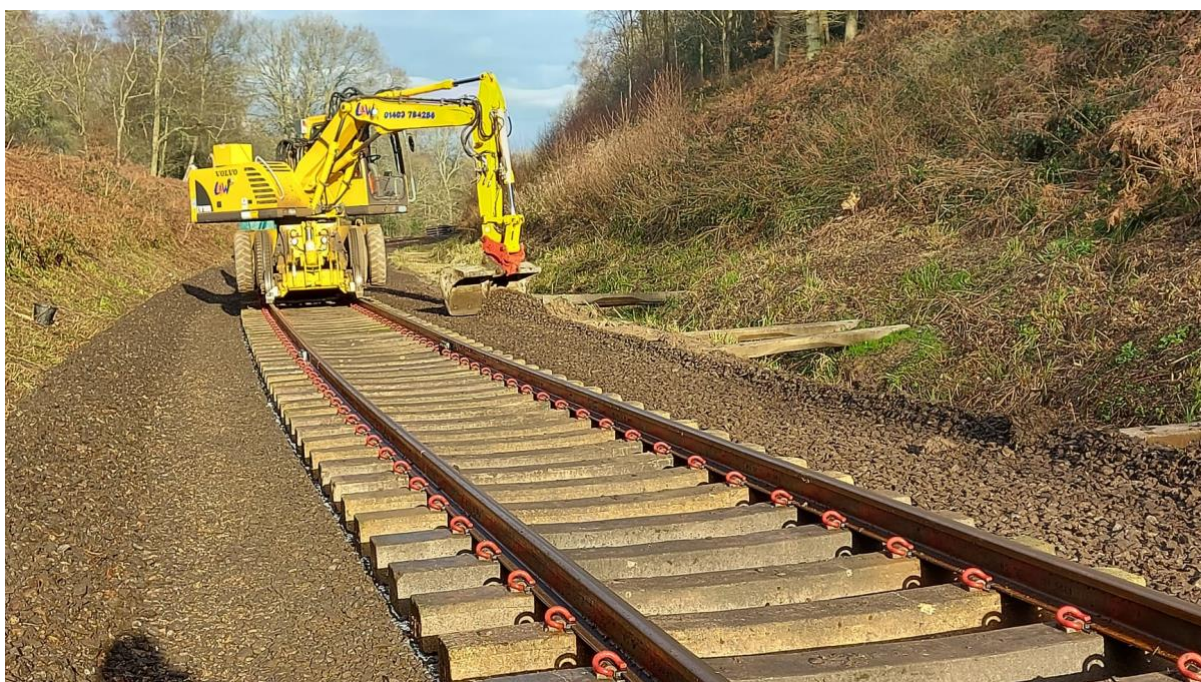
The spare old ballast that was bulldozed aside when remaking the track bed formation is too soil-filled to be reused in between or under the sleepers. Darren in the RRV can be seen grading it out at the sides which will form a decent bed for the new ballast shoulders and give a drainage path to the cess ditch on top of the scraped out and lowered walk-way in the cess.

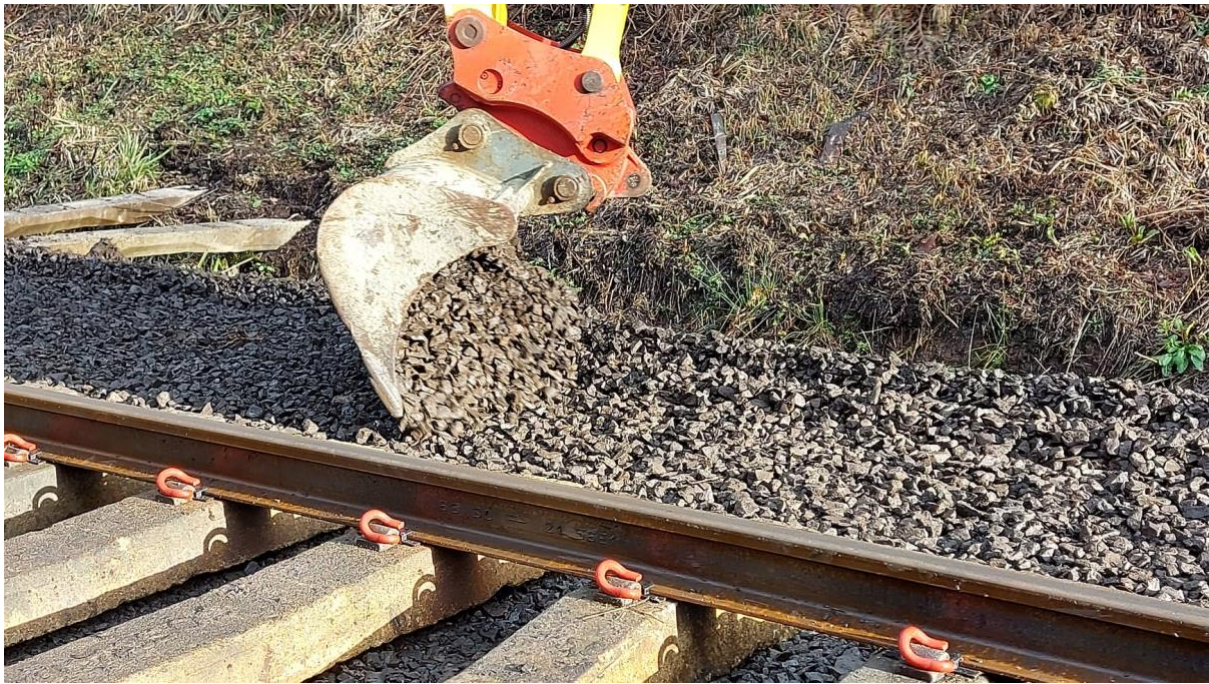
The new track looks very pleasing in the sun, despite being just “as laid” and not having the final alignment done yet, no ballast yet and not tamped either.
