Q Class 541 Overhaul Progress

By Steve Pilcher and Chris Hunford, Maunsell Locomotive Society

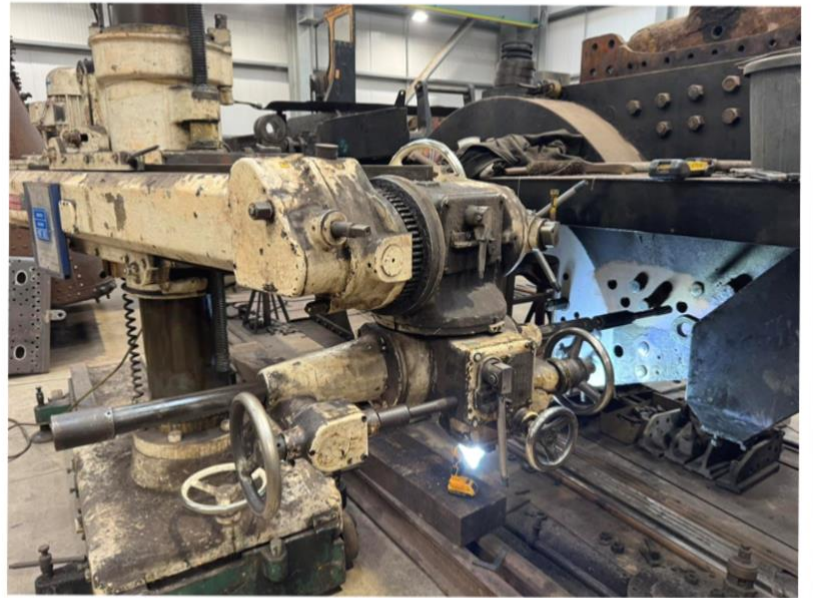
Right: Reaming the right hand fitted bolt holes.
Photo – Leaky Finders

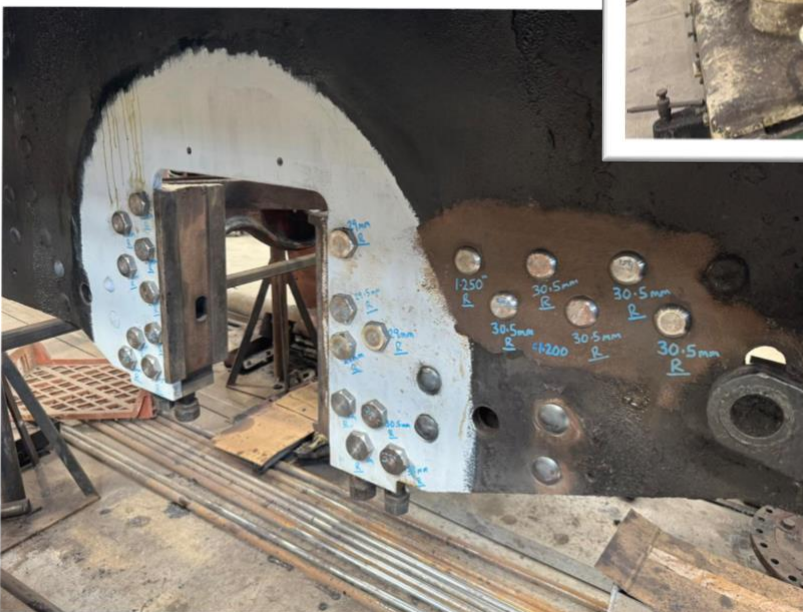
Below: Leading front horn guides in place and new fitted bolts installed to secure the cylinder block.
Photo – Leaky Finders

Work is progressing well on the chassis at Leaky Finders, with the first of the new frame inserts having been welded into place. The leading and trailing horn blocks have all been fitted, using new bolts that have been machined on site.

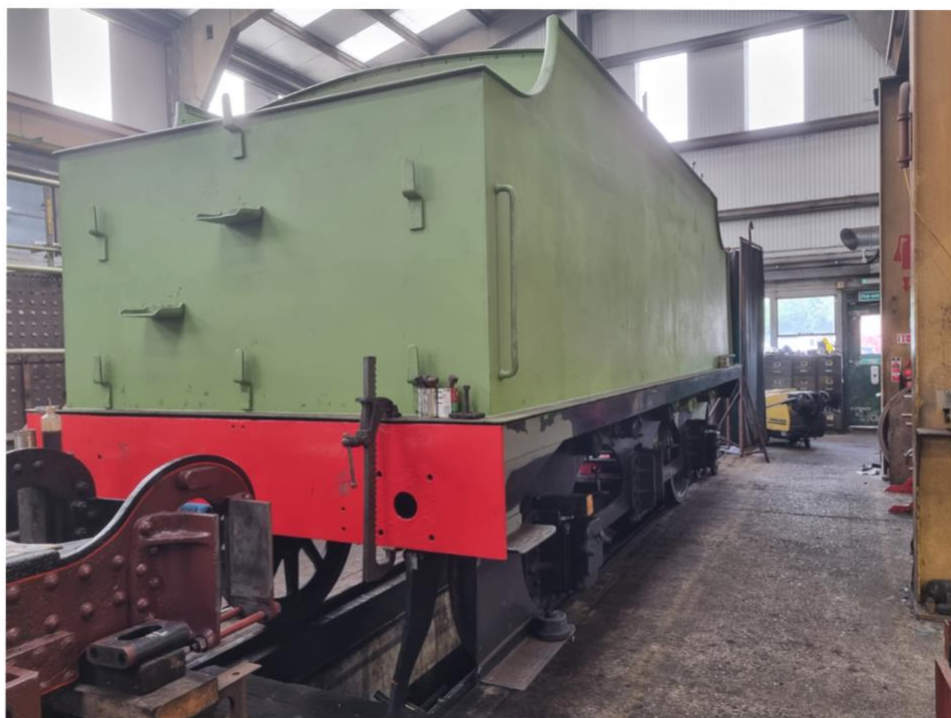
Left: Tender tank and chassis temporarily re-wheeled. Photo – Steve Pilcher

Back at Sheffield Park, the tender has been temporarily re-wheeled to move it out of the workshop for the duration of model railway weekend. In due course the tender tank will be lifted off to enable it to be painted.

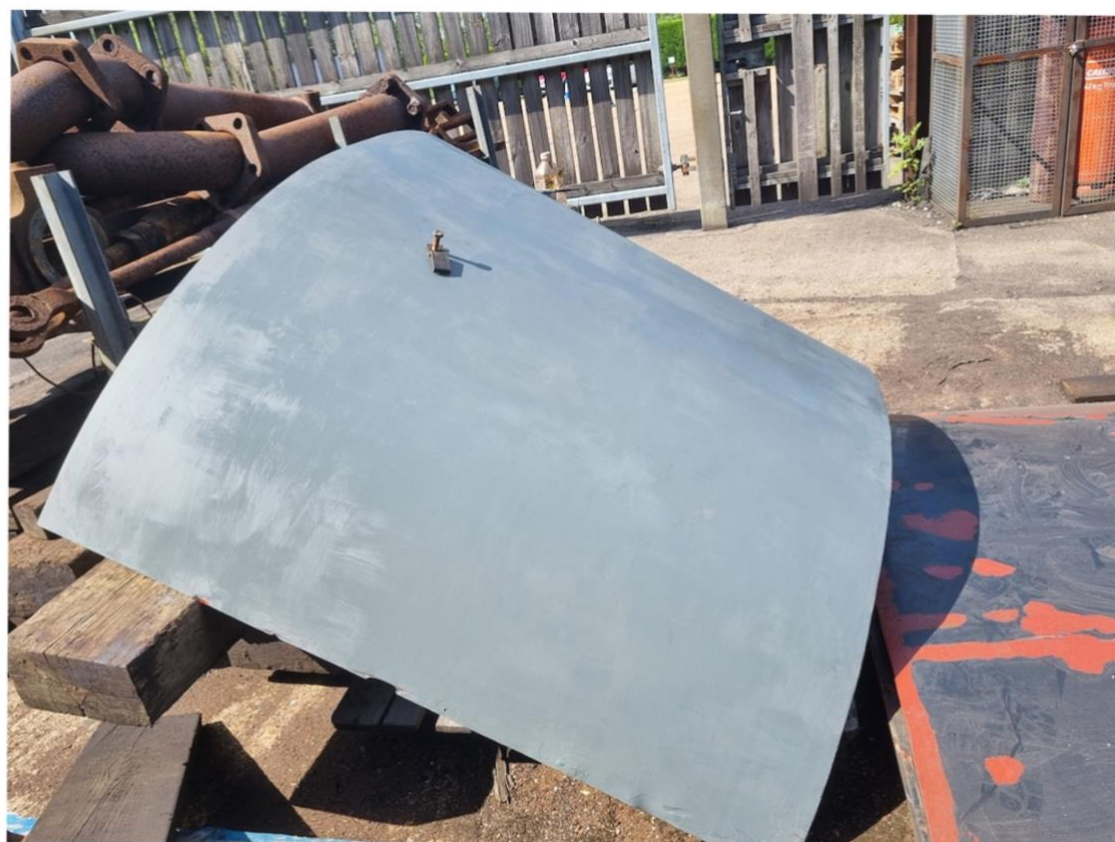
Below: Boiler cladding in first coat of undercoat. Photo – Steve Pilcher

The Maunsell Locomotive Society volunteers have continued cleaning and priming various sections of the loco's boiler cladding that are present at Sheffield Park.
